STEAM PADDLE TUG EPPLETON HALL

Historic Structure Report
1990
DRAFT

Historic Structure Report

Tri-Coastal Marine, Inc.
200 Burrows Street
San Francisco, CA. 94134

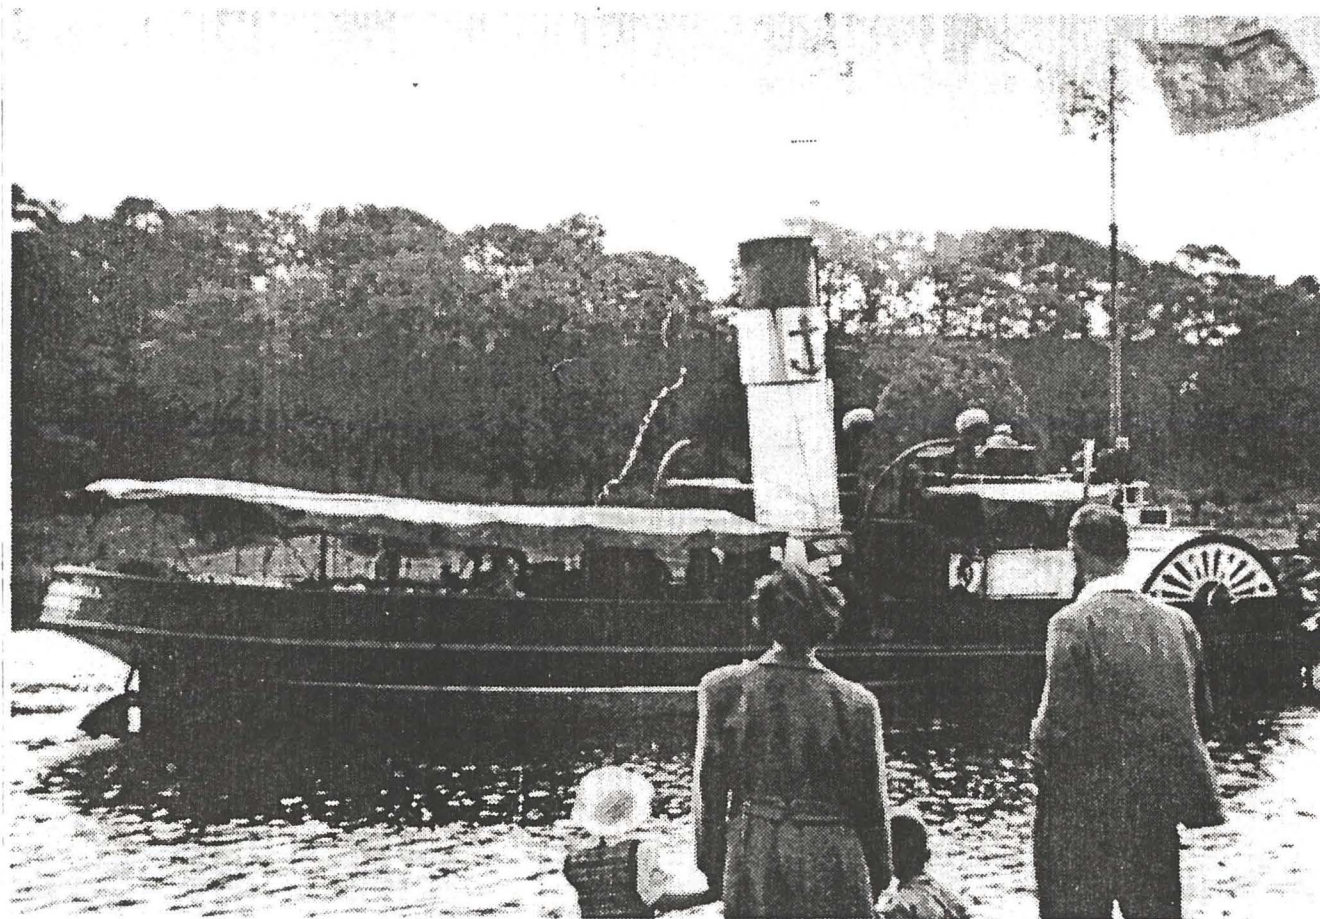
Photo: SFMNH 17.23521

A historic photograph dated ~~1953~~ (~~SFMNHP #11.24353~~) shows the top of her pilothouse to have been removed. The panelled wood sides remain, but they only extend up to the former window sills. This step was probably taken to improve the helmsman's visibility, particularly looking aft, but also would have left the helm exposed to the weather. This alteration was made sometime between 1914 and ~~1953~~. *the middle 1930s*

Fig. 3. EPPLETON HALL, ca. 1950s, wearing the France, Fenwick, Tyne & Wear stack insignia. Note removal of pilothouse top.

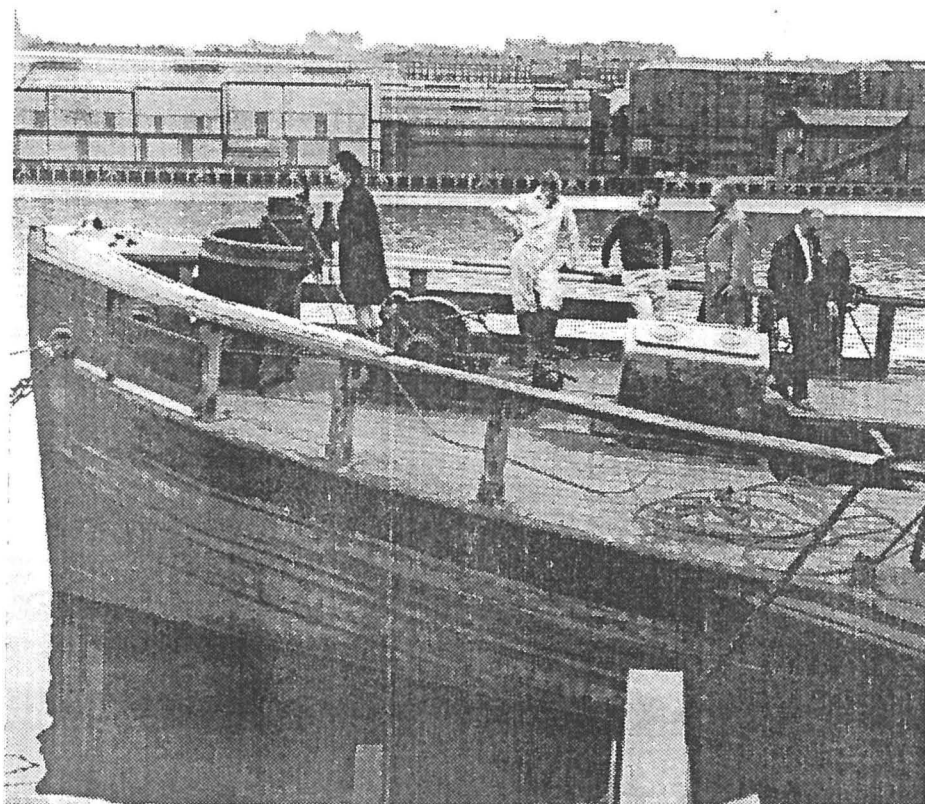
Photo: SFMHP 111.23,999#79

Fig. 5. Scott Newhall and company surveying their acquisition at Clayton and Davy scrapyard in 1969. Note the "towing table" at the bow, an original item removed during the rebuild. The windlass and skylight were restored and are aboard today.

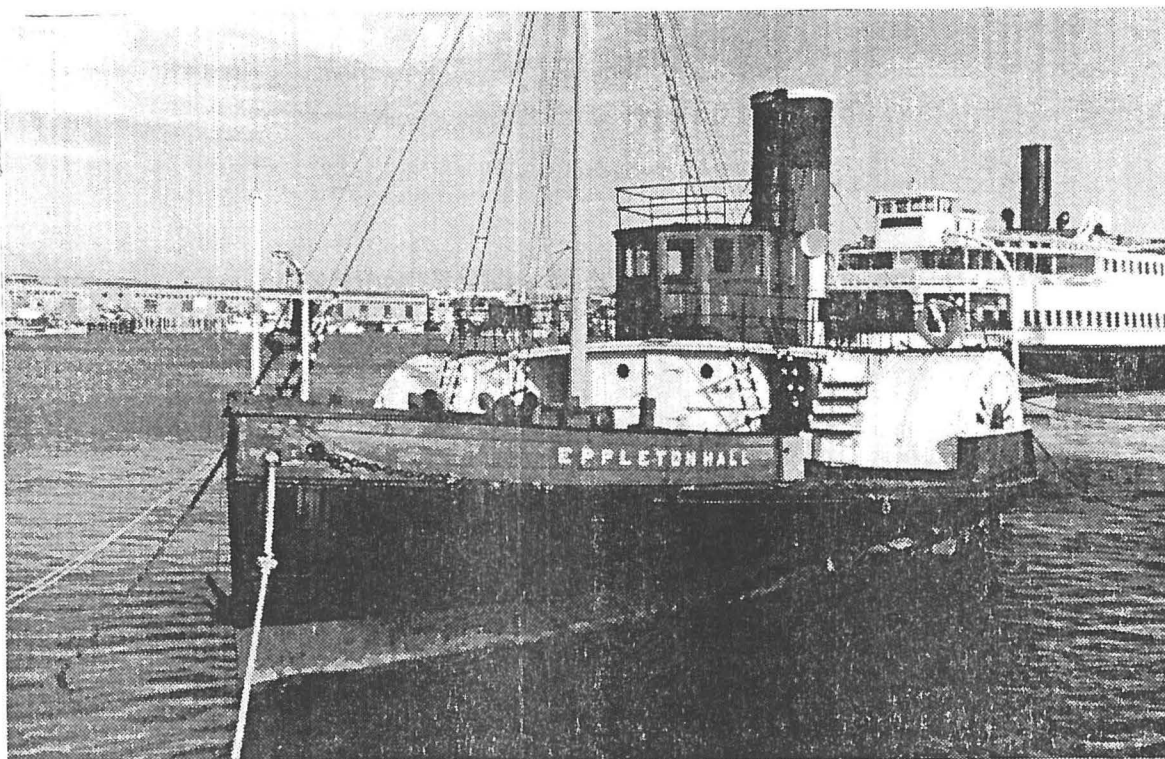
Photo: Tri-Coastal Marine

Since 1987, an effort has been made, both by volunteers and Park staff, to stabilize deteriorating fabric on the vessel. Most of the work has been limited to maintenance steps which, unfortunately, have not appreciably slowed the vessel's rate of deterioration. Although no significant alterations have been made, some historic items have been disassembled and are at risk of being lost or damaged.

Fig. 8. Moored at Hyde Street Pier, SFMNH 1990.

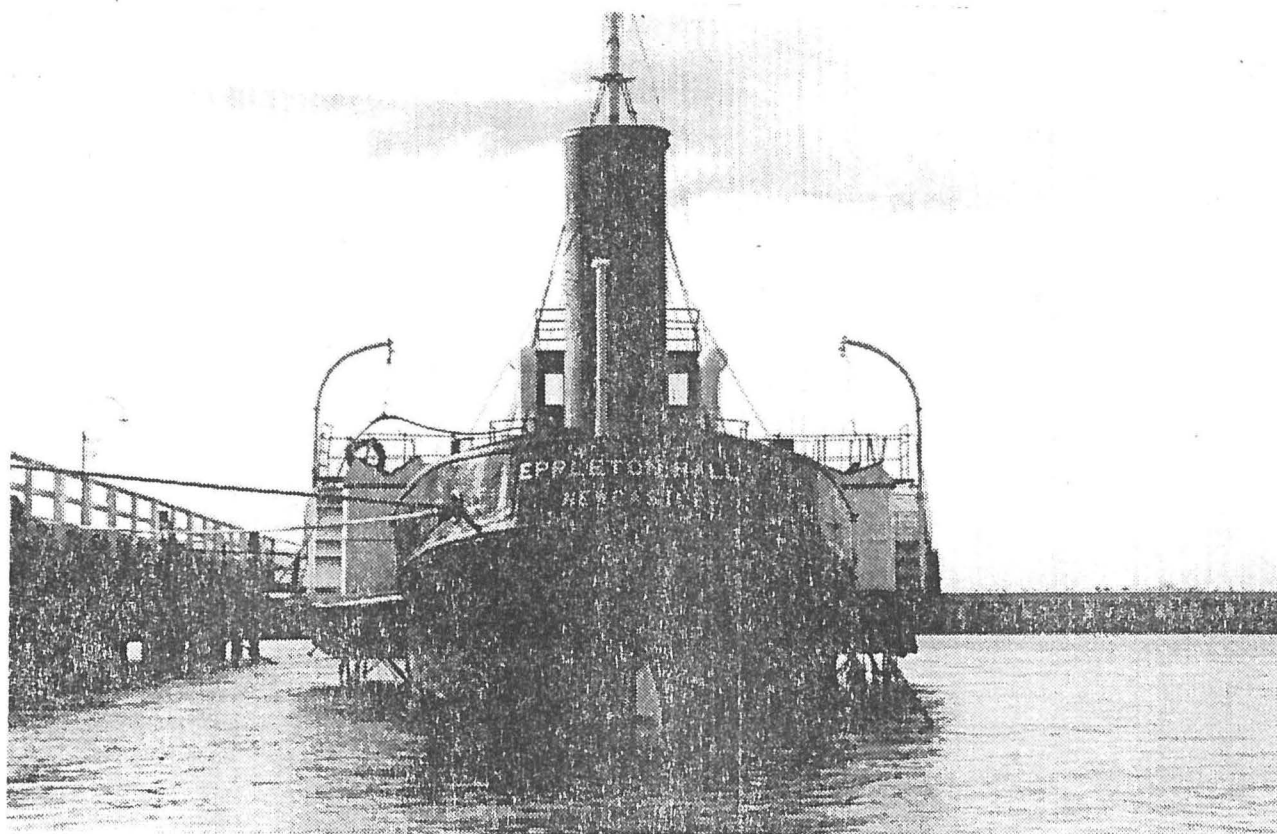
Fig. 12. EPPLETON HALL at her moorings off Hyde Street Pier, as viewed from astern. She remains, unmistakably, a Tyne paddle tug.
